EPA 550-R-97-002

October 1997

EPA/OSHA JOINT CHEMICAL ACCIDENT INVESTIGATION REPORT

Napp Technologies, Inc., Lodi, New Jersey

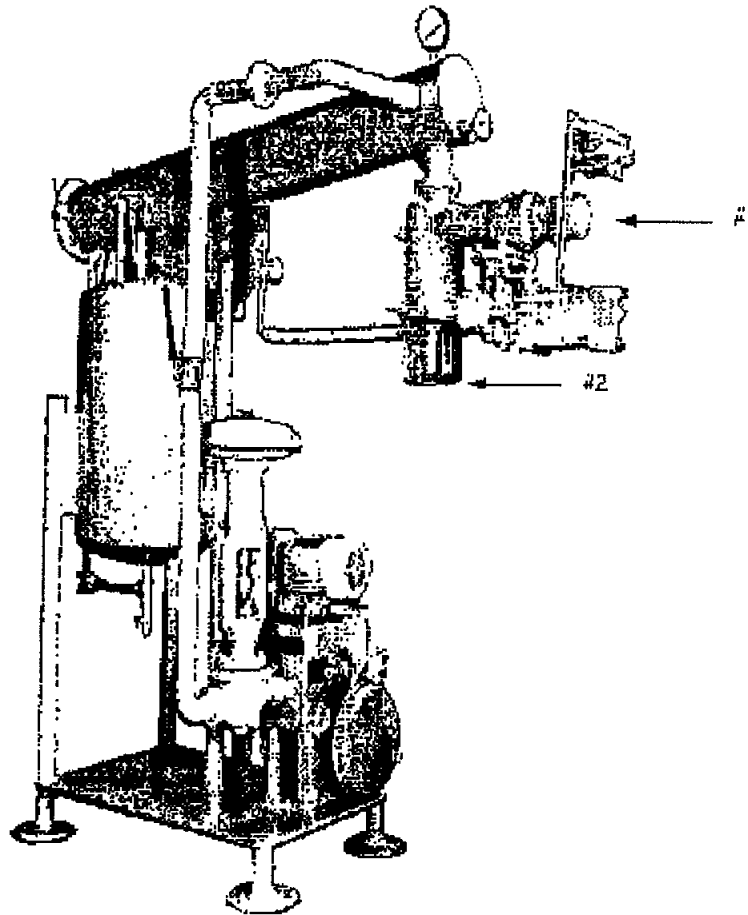
Figure 3A: Typical Vacuum Collection System as Supplied by Patterson-Kelley. #1 shows approximate location of inlet from blender vacuum line; #2 shows vacuum separator bowl.

Between midnight and 4:30 a.m. on April 21, 1995, the third shift attempted to inject benzaldehyde into the batch on two occasions; each attempt failed. Operators observed the benzaldehyde running back into the vacuum separator. During each attempt to add the liquid, the blender was rotated for about two minutes with the intensifier bar running. Suspecting that product was blocking the spray tip of the nozzle
